ALLOY STEEL

ARCOPLATE LINER KIT INSPECTIONS CAT AD55 UNDERGROUND TRAY, 24-11-09 – UNIT UT0027

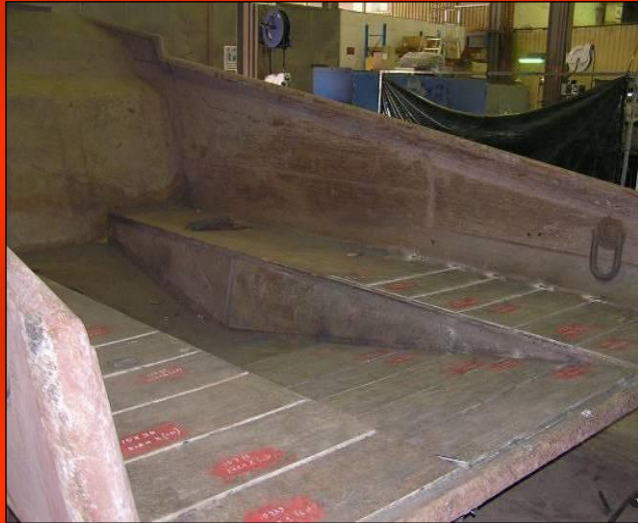
Arcoplate Wear Kit upon completion Nov '08

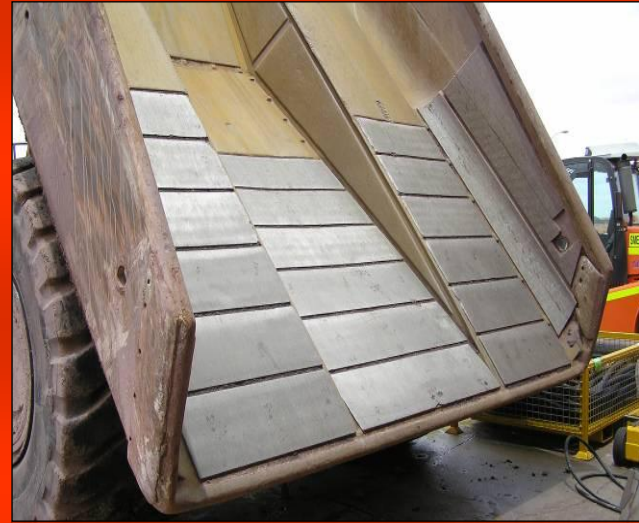
Arcoplate after 12 months service Nov '09

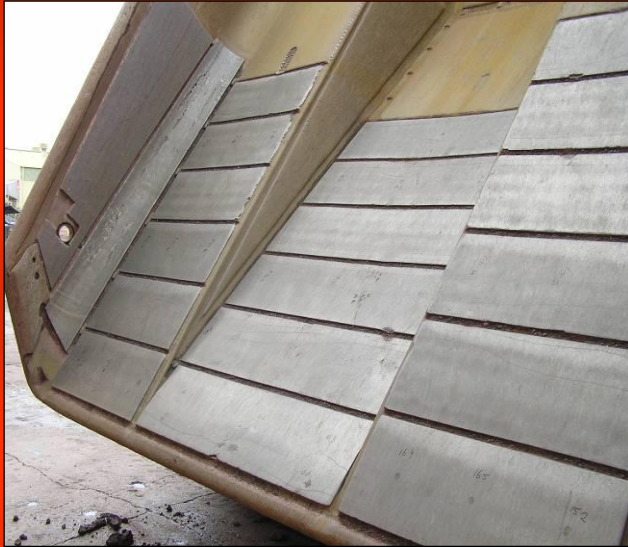
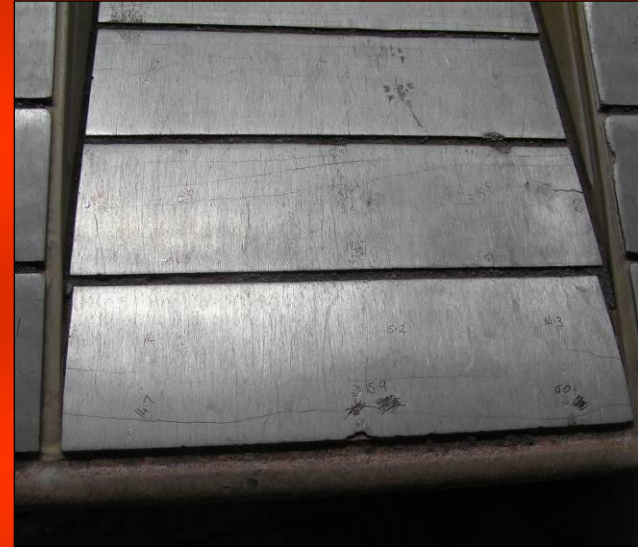
Nov '09. A 15mm average thickness remains on the tail end from the original 8/9 Arcoplate (17mm)

Thickness tests were carried out by a site representative on the Arcoplate Wear Kit - unit UT0027. The Arcoplate has now been in service for 3995 hours. Some minor damage from a hydraulic rock breaker was reported early on (noted throughout previous reports) however; there are no significant areas of interest or repairs required on the Arcoplate to date. The Arcoplate kit does require a little extra education in care and preservation however this is well rewarded with longevity of performance and minimum downtime/maintenance.

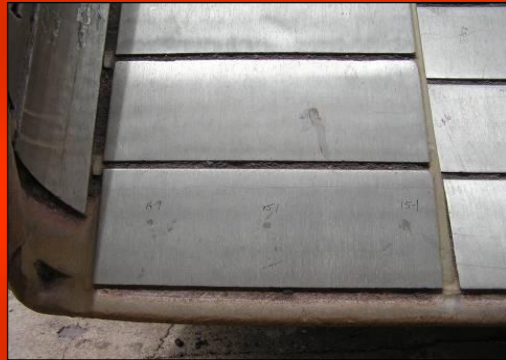
15.0mm

Arcoplate thickness test results on UT0027 as at **24-11-2009**, hour's service is 3995 over twelve months.

Thickness tests were randomly taken over the entire floor. Results used for all calculations were from an average thickness in the highest wear area; being the final row of Arcoplate 8/9
(Nominal supply thickness; 17mm, Nov 08)

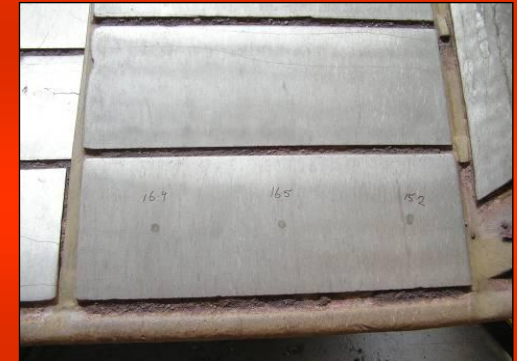
16.2mm
